# TROUBLESHOOTING & MAINTENANCE

## Model 14 Freezeless Wall Faucet

### MODEL 14, 16, 17, 19, 22 WALL FAUCET RETAINER REMOVAL TOOL

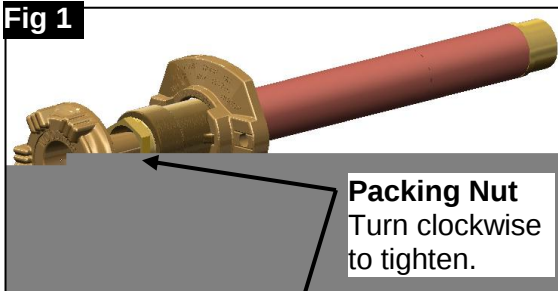
Fig 1

- **Packing leak: Faucet leaks from around the operating stem when it is on**  
The hex **Packing Nut** (30059) will occasionally need to be tightened to stop a packing leak. **(Fig 1)** Without removing any parts, tighten the packing nut behind the handle until snug and the leak stops. Persistent leaks will require a new **EPDM Packing** (30560) **(Fig 2)**.

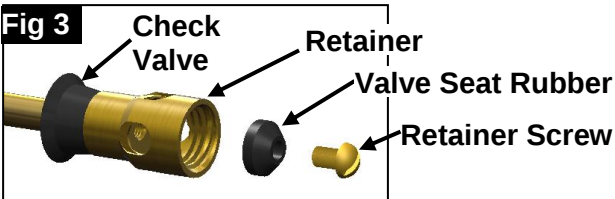
Fig 3

- **Faucet will not shut off: Water runs or drips out nozzle when the faucet is off**  
The **Valve Seat Rubber** (30008) is worn or damaged and needs to be replaced or the **Retainer Screw** (30009) is loose. **(Fig 3)** Follow the instructions below on how to remove the **Operating Rod**. **(Fig 4 & 5)** If this does not fix the leak, the faucet may have a damaged seat and the faucet will need to be replaced.

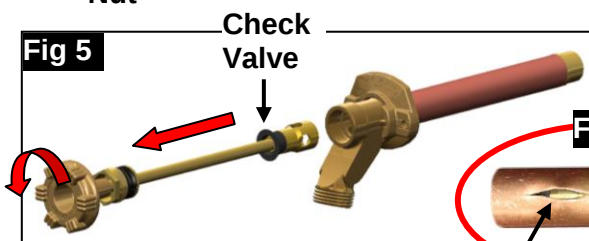
Fig 5

- **Valve Stem Assembly - Operating Rod Removal**  
To remove the operating rod from the faucet, shut off the water supply, loosen the handle and back out the **Packing Nut** **(Fig 4)**. Use the handle to turn the rod counterclockwise until the rod becomes disengaged from the valve seat. Use a small screwdriver to pry the packing loose. Pull the rod assembly out of the faucet. **(Fig 5)** The rod may have a check valve that will add resistance to removal. Use a swift pull to disengage it.

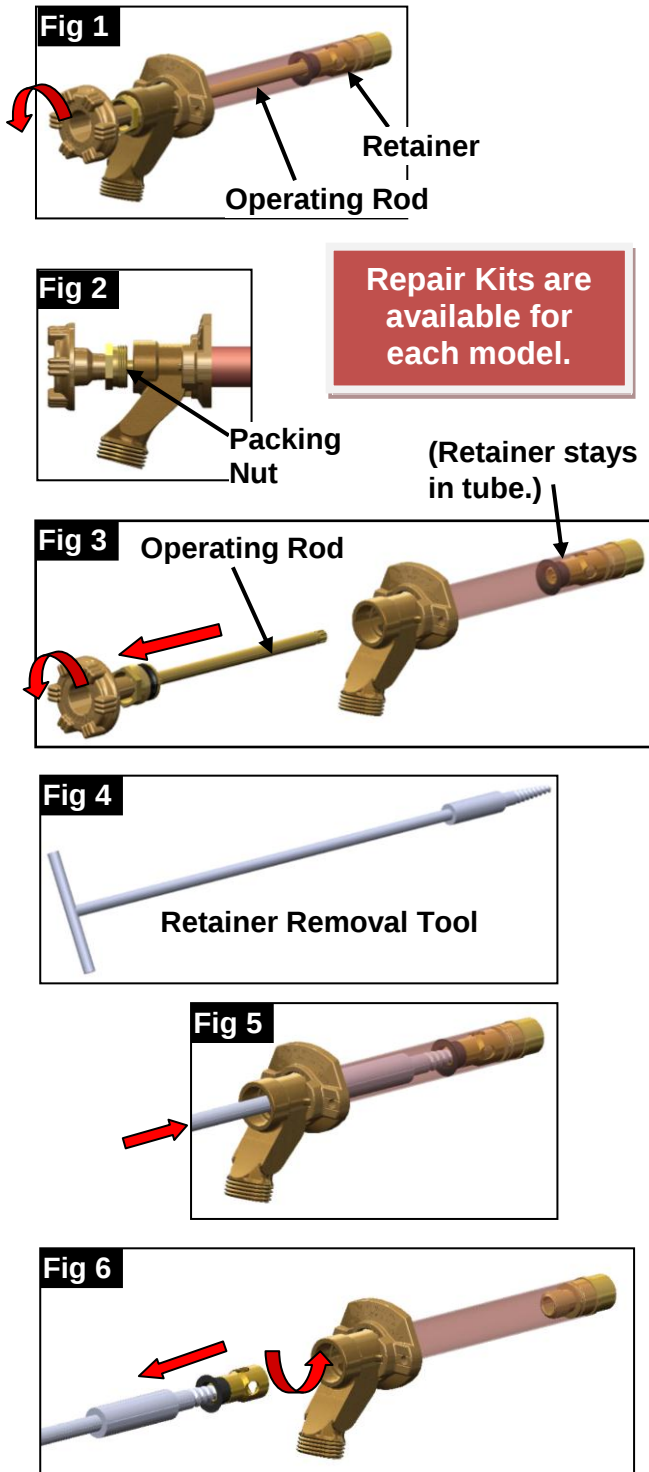
- **Handle turns but does not open or close faucet properly.**  
If the handle continues to turn after shut off, the **Retainer (Fig 1)** may be disengaged from the end of the **Operating Rod**.  
**A replacement operating rod is required for repair.**
- **Valve stem assembly (operating rod) removal.**  
To remove the operating rod from the faucet, shut off the water supply to the faucet and loosen the handle and back out the **Packing Nut (Fig 2)**. Use the handle (**Fig 3**) to turn the rod counterclockwise until the rod becomes disengaged from the valve seat. Use a small screwdriver to pry the packing loose. Pull the rod out of the faucet. The rod may have a check valve that will add resistance to removal, but a swift pull will disengage it.

If the retainer becomes disengaged from the end of the operating rod (**Fig 3**), first try to reinsert the operating rod or insert a screwdriver and turn counterclockwise until the retainer unthreads from the valve seat. If the retainer does not come out with the operating rod, water pressure may be required to push the retainer out of the tube.

If the retainer cannot be retrieved by the operating rod or a screwdriver, a special **Retainer Removal Tool (Fig 4)** is available on loan from Woodford. Please call or email us with your address info and we will forward it to you. [sales@woodfordmfg.com](mailto:sales@woodfordmfg.com)
- **Instructions for using retainer removal tool.**  
With the operating rod removed, insert the tool until it engages inside the retainer. (**Fig 5**) Turn the tool counterclockwise until the retainer unthreads from the valve seat. (**Fig 6**) If the retainer does not come out with the removal tool, water pressure may be required to push the retainer out of the tube.
