Vero™ Tub/Shower Trim Garniture pour Bain/Douche Vero™

Models/Modelos/Modèles T14053, T14253 & T14453 Series/Series/Seria

Cartridge Summary Reference Sheet

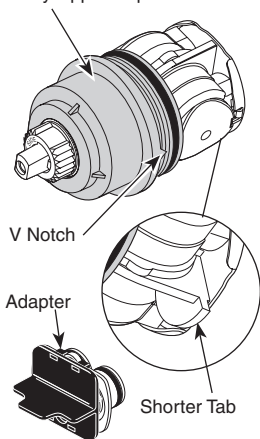
17

Grey Upper Cap

Order RP46463 to Replace Cartridge.

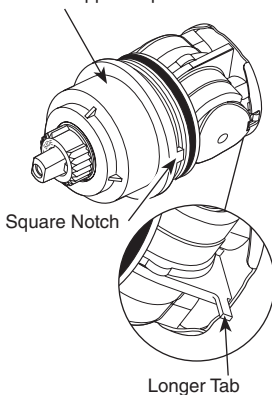
1700

White Upper Cap

Order RP32104 to Replace Cartridge.
