Regal® Flushometer

NOTE: Also for use with Regal® XL
(Since mid-2010)

The repair kits and parts listed on this page are designed to service all Sloan diaphragm type flushometers, including those manufactured for low consumption (LC) usage.

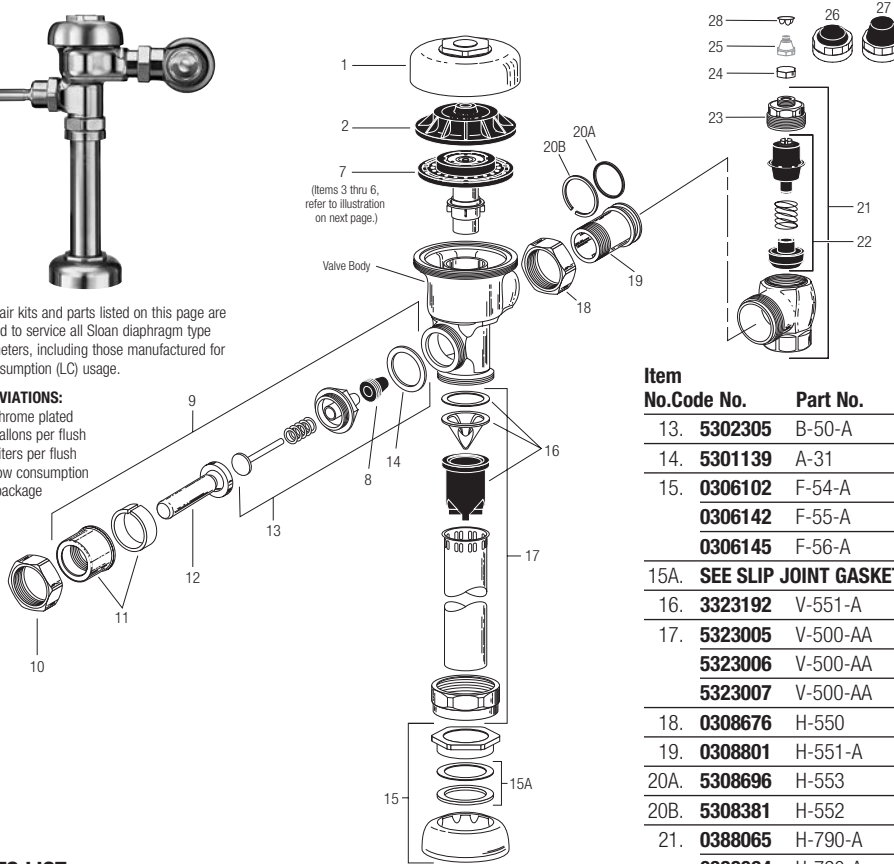
PARTS LIST

Item No.	Code No.	Part No.	Description
1.	0317004	R-10	CP Cover
	—	R-10-HE	CP High Efficiency Cover
2.	0301168	A-71	Inside Cover
SEE ITEMS 3A THROUGH 6E IN CHART ON NEXT PAGE			
3A.	5301058	A-19-AC	Relief Valve, White (Closet) – 12 per package
3B.	5301059	A-19-AU	Relief Valve, Black (Urinal) – 12 per package
3C.	5301211	A-19-ALC	Relief Valve, Green (Closet/Urinal-LC) – 12 per package
3D.	0301143	A-19-AL	Relief Valve, Blue (9 Liter Closet)

4.	5301111	A-15-A	Disc – for all Inside Parts Kits – 12 per package
5.	5301188	A-156-A	Diaphragm – for all Inside Parts Kits – 12 per package
6A.	5301236	A-163-A	Guide Assembly 4.5 gpf/17.0 Lpf Closet & 1.5 gpf/5.7 Lpf Urinal – 12 per package
6B.	5301032	A-152-A	Guide Assembly 3.5 gpf/13.2 Lpf Closet – 12 per package
6C.	5301031	A-151-A	Guide Assembly 1.6 gpf/6.0 Lpf LC Closet – 12 per package
6D.	5301155	A-155-A	Guide Assembly 1.0 gpf/3.8 Lpf LC Urinal – 12 per package
6E.	5301157	A-157-A	Guide Assembly 0.5 gpf/1.9 Lpf Urinal – 12 per package

7.	SEE INSIDE PARTS KITS CHART ON NEXT PAGE		
8.	5302297	B-39	Seal – 12 per package
9.	5302279	B-32-A	CP Handle Assembly – 6 per package
	0302390	B-73-A	CP Handicap Handle Assembly (ADA Compliant)

10.	0301082	A-6	CP Handle Coupling
11.	0302109	B-7-A	CP Socket Assembly
12.	5302274	B-32	CP Handle Grip – 12 per package
	0302389	B-74-A	CP Handicap Handle Grip (ADA Compliant)

Item No.	Code No.	Part No.	Description
13.	5302305	B-50-A	Handle Repair Kit – 6 per package
14.	5301139	A-31	Handle Gasket – 48 per package
15.	0306102	F-54-A	3/4" CP Spud Coupling Assembly
	0306142	F-55-A	1-1/4" CP Spud Coupling Assembly
	0306145	F-56-A	1-1/2" CP Spud Coupling Assembly
15A.	SEE SLIP JOINT GASKETS AND RINGS TABLE BELOW

16.	3323192	V-551-A	Vacuum Breaker Repair Kit
17.	5323005	V-500-AA	3/4" x 9" CP Vacuum Breaker – 6 per package
	5323006	V-500-AA	1-1/4" x 9" CP Vacuum Breaker – 6 per package
	5323007	V-500-AA	1-1/2" x 9" CP Vacuum Breaker – 6 per package

18.	0308676	H-550	CP Stop Coupling †
19.	0308801	H-551-A	CP Adjustable Tailpiece 2-1/16" long †
20A.	5308696	H-553	O-ring – 24 per package
20B.	5308381	H-552	Locking ring – 12 per package

21.	0388065	H-790-A	1" Screwdriver Bak-Chek® Stop CP – complete
	0388064	H-790-A	3/4" Screwdriver Bak-Chek® Stop CP – complete
	0388029	H-740-A	1" Screwdriver Bak-Chek® Stop CP – OBSELETE
	0388031	H-740-A	3/4" Screwdriver Bak-Chek® Stop CP – OBSELETE

22.	3308853	H-541-ASD	1" Control Stop Repair Kit *
	3308856	H-543-ASD	3/4" Control Stop Repair Kit **
23.	0308612	H-622	CP Bonnet (Current Regal)
	0308991	H-639	CP Bonnet – Pre 2010 Regal Stops*
	0308601	H-538	CP Bonnet ** – OBSELETE

24.	5388001	H-1012-A	CP Cap – 6 per package VP
25.	5310034	J-2/J-7	Bumper Assembly – 6 per package – OBSELETE
26.	3308866	H-574	Stop Cap, chrome plated with Seat Bumper (-YO)

27.	3308867	H-576	Stop Cap, chrome plated with Extended Seat Bumper (-YG)
28.	5388002	H-528	Hole Plug
29.	3388015	H-1015	Flow Control Kit (HEU Only) (not Shown)

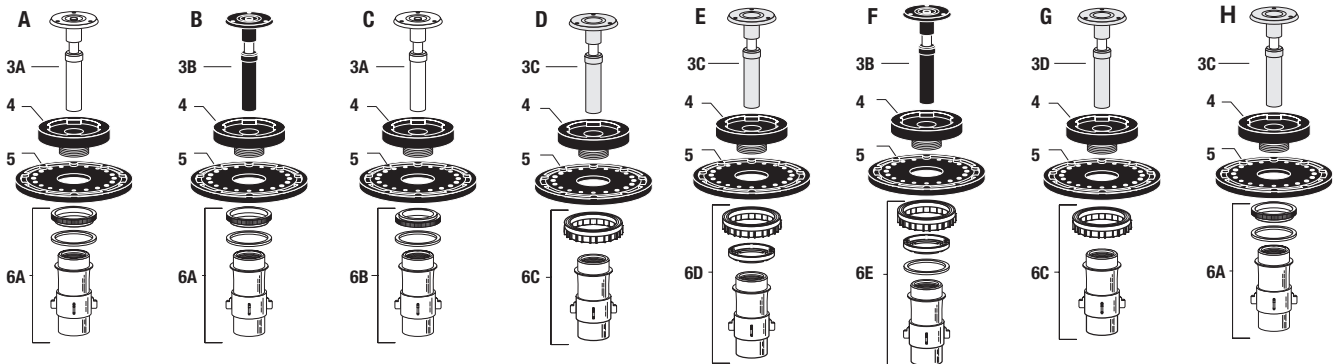
ITEM 7. INSIDE PARTS COMPONENTS (SEE ILLUSTRATIONS BELOW)

ITEM 7. INSIDE PARTS KITS (SEE ILLUSTRATIONS BELOW)

Item No.	Code No.	Part No.	Application
A.	3301036	A-36-A	4.5 gpf/17.0 Lpf - Closet
B.	3301037	A-37-A	1.5 gpf/5.7 Lpf - Urinal
C.	3301038	A-38-A	3.5 gpf/13.2 Lpf - Closet
D.	3301041	A-41-A	1.6 gpf/6.0 Lpf - Closet
E.	3301044	A-42-A	1.0 gpf/3.8 Lpf - Urinal
F.	3301081	A-43-A	0.5 gpf/1.9 Lpf - Urinal
G.	3301024	A-44-A	2.4 gpf/9.0 Lpf - Closet

H. **3301045** A-140-A 1.28 gpf/4.8 Lpf - Closet

Item No.	Code No.	Part No.	Description
3A.	5301058	A-19-AC	Relief Valve, White (Closet) – 12 per pkg.
3B.	5301059	A-19-AU	Relief Valve, Black (Urinal) – 12 per pkg.
3C.	5301211	A-19-ALC	Relief Valve, Green (Closet/Urinal-LC) – 12 per pkg.
3D.	0301143	A-19-AL	Relief Valve, Blue (9 Liter Closet)
4.	5301111	A-15-A	Disc – for all Inside Parts Kits – 12 per pkg.
5.	5301188	A-156-A	Diaphragm – for all Inside Parts Kits – 12 per pkg.
6A.	5301236	A-163-A	Guide Assembly 4.5 gpf/17.0 Lpf Closet & 1.5 gpf/5.7 Lpf Urinal – 12 per package
6B.	5301032	A-152-A	Guide Assembly 3.5 gpf/13.2 Lpf Closet – 12 per package
6C.	5301031	A-151-A	Guide Assembly 1.6 gpf/6.0 Lpf LC Closet – 12 per package
6D.	5301155	A-155-A	Guide Assembly 1.0 gpf/3.8 Lpf LC Urinal – 12 per package
6E.	5301157	A-157-A	Guide Assembly 0.5 gpf/1.9 Lpf Urinal – 12 per package

4.5 gpf/17.0 Lpf

1.5 gpf/5.7 Lpf

3.5 gpf/13.2 Lpf

1.6 gpf/6.0 Lpf

1.0 gpf/3.8 Lpf

0.5 gpf/1.9 Lpf

2.4 gpf/9.0 Lpf

1.28 gpf/4.8 Lpf
